TORREYA

THE CLOGGING OF DRAIN TILE BY ROOTS

BY G. E. STONE

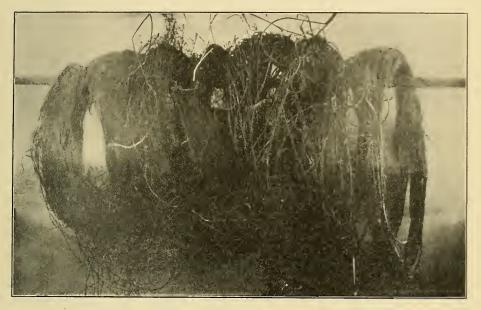
FIG. 1.-Showing pear tree root taken from drain tile.

for roots of various kinds, if so disposed, to penetrate the joints of the pipe and secure an abundant supply of water. During November, 1909, about seven years after the drain pipe was installed, it became necessary to dig up a large part of it on account of its inefficiency and replace it. It was found on digging up this tile that it was badly congested by a profuse root growth. A careful examination of the location showed that this growth

of roots originated from a single off-shoot of a pear tree located some seven feet away. This enormous mass of pear roots was removed from the tile and carefully laid aside and at our request was presented to our museum, with full data concerning it. The roots were found to measure 61 feet in length. Only a single root entered the tile, it having a diameter of about fiveeighths of an inch inside the tile, but where it entered the tile it was somewhat flattened out. The root, on entering the tile, subdivided into innumerable rootlets, and these were again divided into countless smaller roots. At the time the tile was

dug up and the roots removed the drain had been in operation seven years, although a cross-section of the root and an examination of the annular rings where it entered the tile, showed that it was only five years old. It required, therefore, only five years for this mass of roots to clog up a 12-inch tile.

The maximum diameter of this mass of roots in the dry state is six or seven inches, but when alive and flourishing in the tile its diameter exceeded this. The roots as they reached the laboratory had a decidedly bad odor, showing that if no sewage was present in the tile there was certainly a considerable amount of organic matter in the seepage derived from the soil or some other source which proved of value as plant food. Soon after the specimens arrived at this laboratory they were spread out on the floor and measured. This was done by laying out on the floor sections five feet in length. The number of roots in each five-foot section was counted. These were multiplied by the length of the section and the whole tabulated (see table). The total length of these roots was 8,498 feet, as shown in the table, which is equal to 1.61 miles. Adding to this the numerous small roots which range from a few to several inches in length and which were not considered in our section count, the total length was estimated to be over two miles.
